# EMERGENCY ACTION PLAN

FAWN LAKE DAM  
SPOTSYLVANIA COUNTY, VIRGINIA

Inventory Number: 17709

March 2011

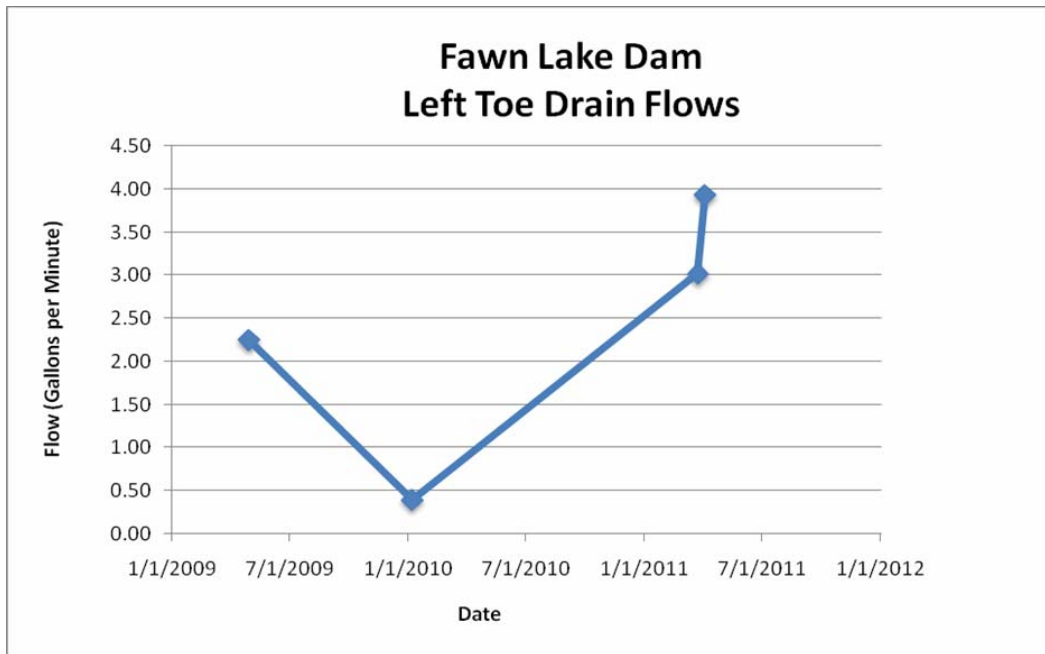
There is a weir box located to the left the principal spillway that measures the quantity of flow from the left toe drain.

**Flow Rates for a 90 degree V-Notch Weir where H is the depth of water measured at the upstream side of the weirbox**
